Inspection Report

Property Address:
9999 Main Street
Greenwood IN 46999

Crawford Home Inspections

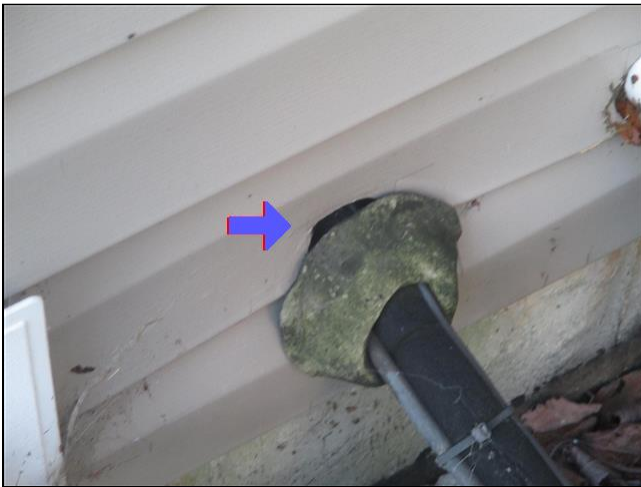
1.1 Item 1(Picture)

1.1 The opening around the air conditioner line requires sealing. This will prevent water and bugs from entering the home.

The opening around the air conditioner line requires sealing. This will prevent water and bugs from entering the home.

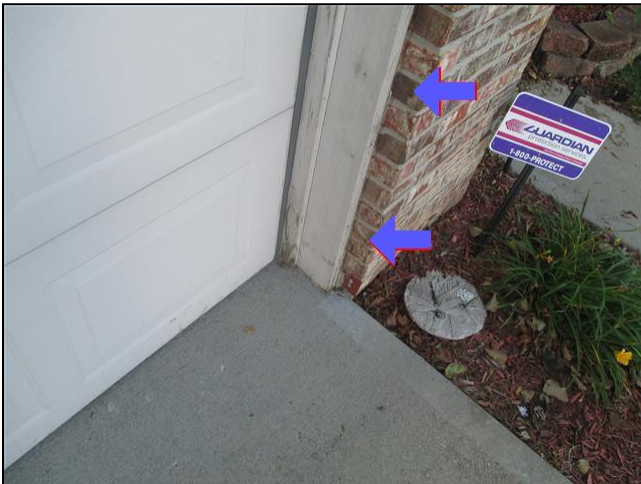
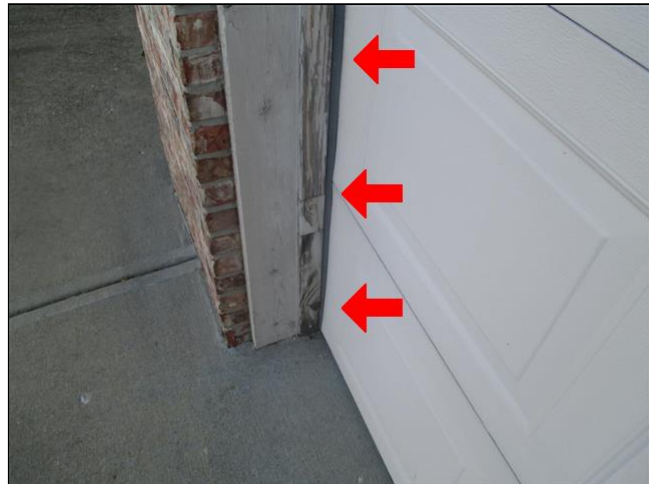
1.3 Item 1(Picture)

1.3 The trim around the garage door requires painting to prevent decay.

The trim around the garage door requires painting to prevent decay.

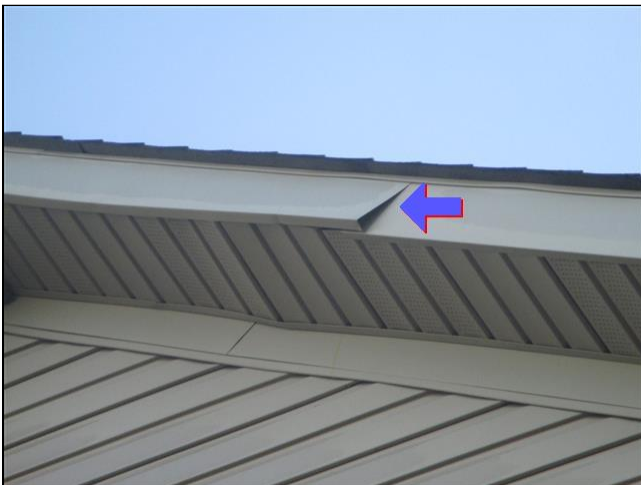
1.4 Item 1(Picture)

1.4 There is trim above the garage that requires adjustment to prevent further damage.

There is trim above the garage that requires adjustment to prevent further damage.

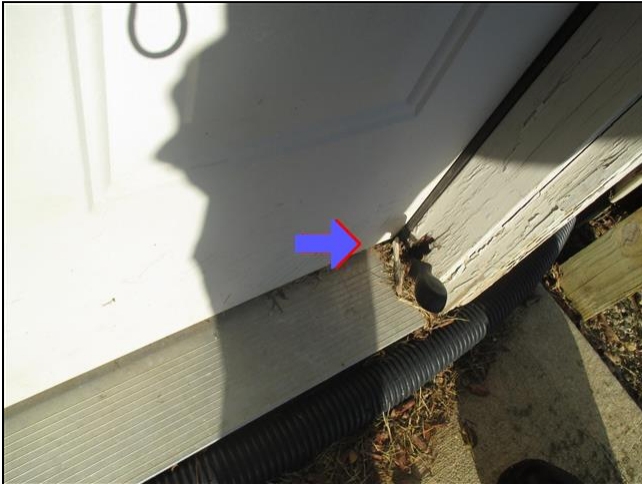
1.5 Item 1(Picture)

1.5 The rear door entering the garage requires repair to the wood frame due to decay and then painted to prevent further damage.

The rear door entering the garage requires repair to the wood frame due to decay and then painted to prevent further damage.

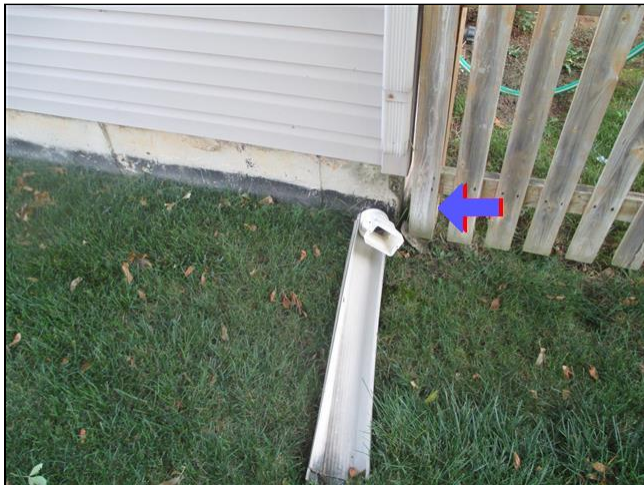
2.4 Item 1(Picture)

2.4 Downspout on right rear corner needs adjusted to direct water away from the foundation.

Downspout on right rear corner needs adjusted to direct water away from the foundation.

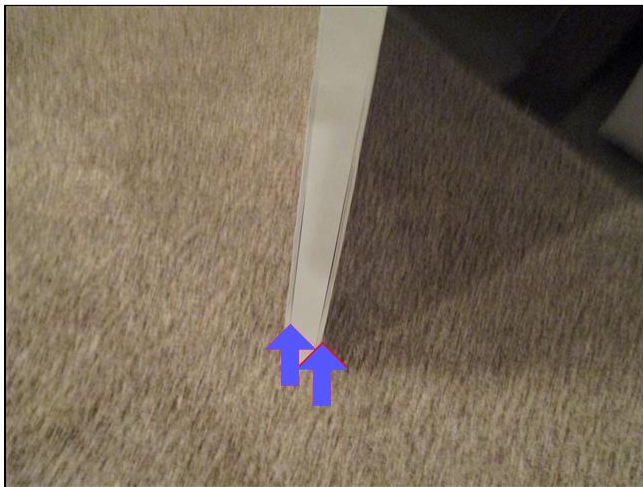
7.4 Item 1(Picture)

7.4 There is one door in the basement that needs adjusted. It is too long and dragging the carpet. This is causing damage to the bottom of the door. This needs to be fixed to prevent further damage.

There is one door in the basement that needs adjusted. It is too long and dragging the carpet. This is causing damage to the bottom of the door. This needs to be fixed to prevent further damage.

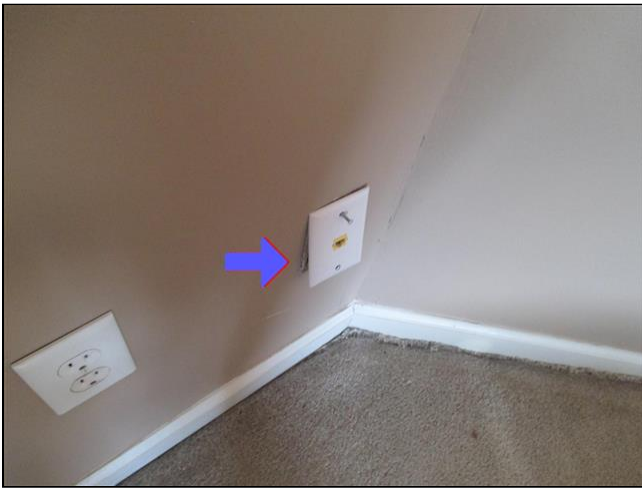
7.6 Item 1(Picture)

7.6 There's a loose cover plate in the Master Bedroom that needs attached.

There's a loose cover plate in the Master Bedroom that needs attached.

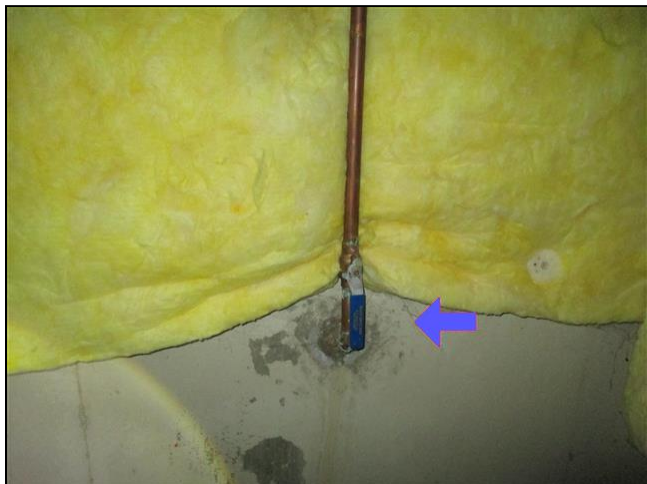
9.3 Item 1(Picture)

9.3 The main water shut off to the house is located on the left wall of the utility room in the basement. Just to the right of the escape window.

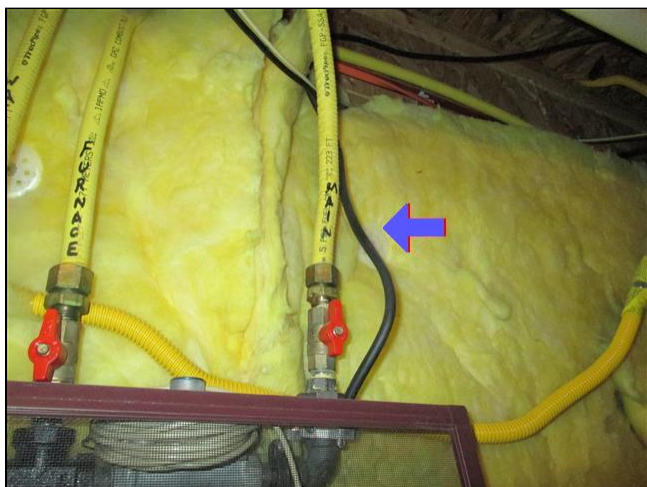
9.5 Item 1(Picture)

9.5 The main gas shut off to the home is located in the utility room in the basement. Just to the left as you walk in.

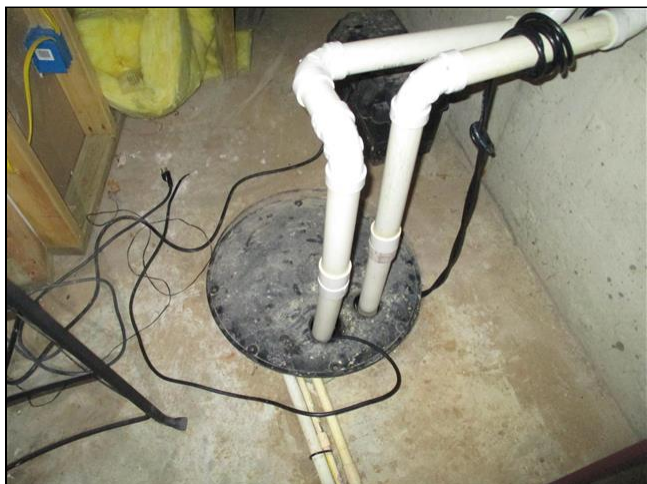
9.6 Item 1(Picture)

9.6 I was unable to test the sump pump because it had a submersed switch and a sealed lid. I found no evidence of water back up and the pump appears to be working properly.

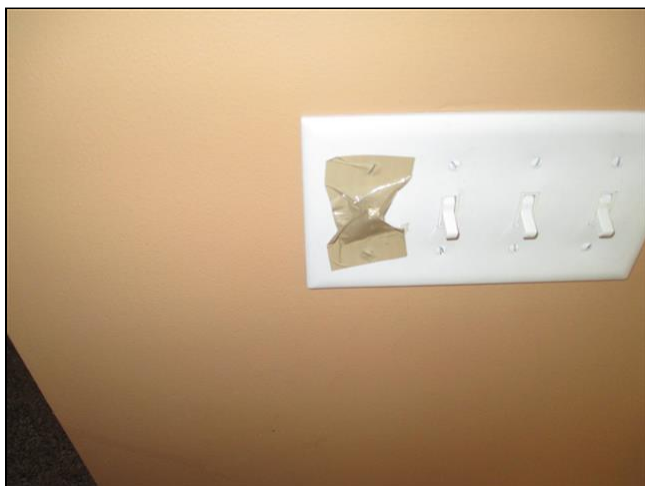
10.3 Item 1(Picture)

10.3 There is a switch in the great room (with fireplace) that has a switch taped in the on position. I have no idea why this would be taped in the on position and recommend that this be inspected by a qualified Electrician to determine if this is a hazard.

There is a switch in the great room (with fireplace) that has a switch taped in the on position. I have no idea why this would be taped in the on position and recommend that this be inspected by a qualified Electrician to determine if this is a hazard.
